MGB VDO Clock Repair

[Michael Stedman's Journal - MGB Clock Repair : The MG Experience](#)

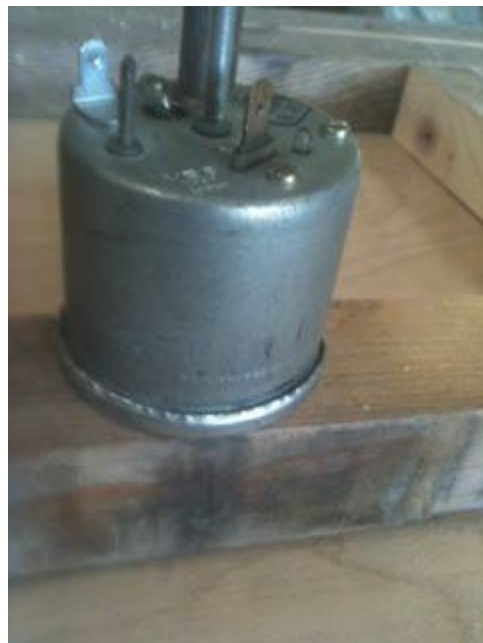
Next, even before removing the screws in the back of the case, the ground connection to the case must be de-soldered.

Once the ground has been de-soldered, the three screws in the back of the case can be removed. Once the screws are removed, the mechanism will be free and can be carefully extracted from the case. Remember to stow the three screws someplace where they won't be lost.

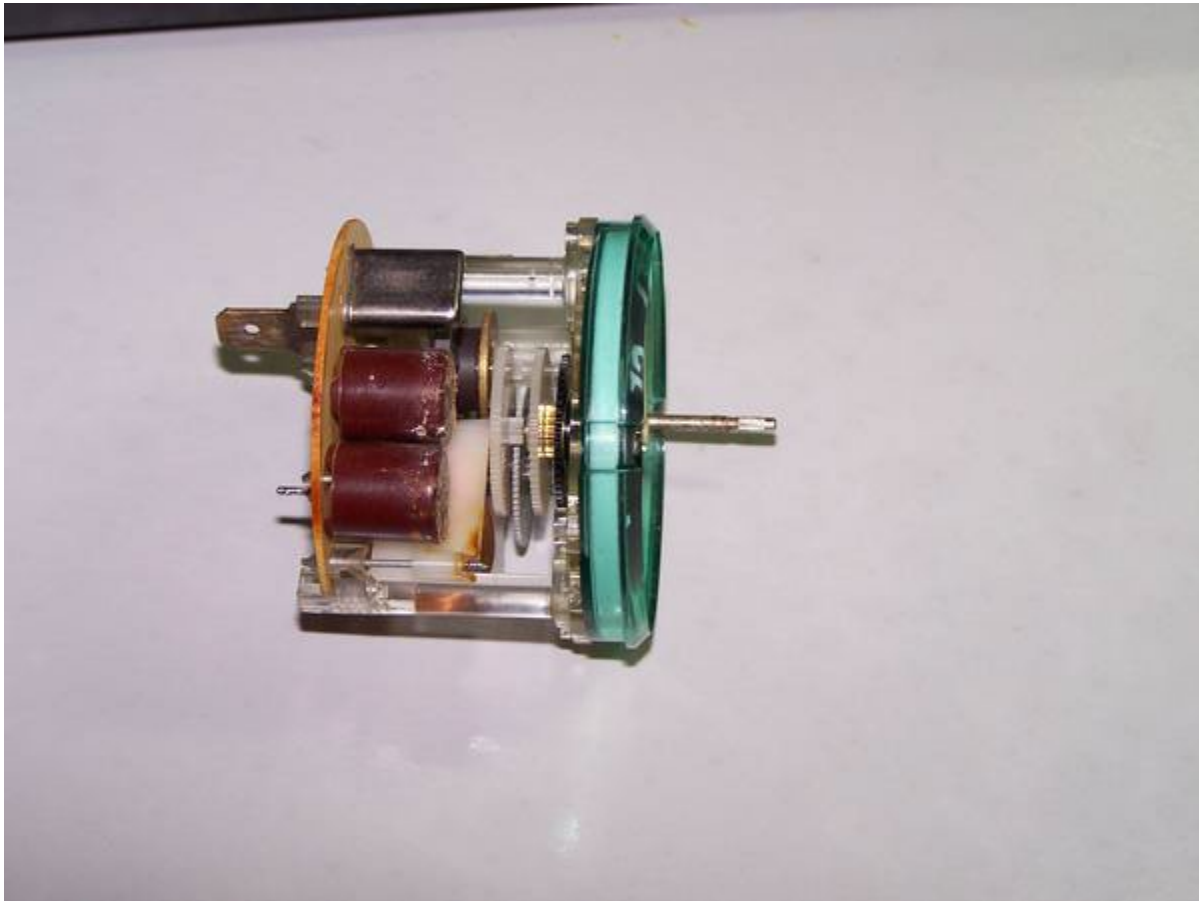
Now that the works are exposed you can inspect the clock for damage.

Carefully inspect that gears and other mechanical parts for damage, missing teeth on the gears, or gunk blocking the function of the movement. If the mechanism is full of dirt and gunk, a good careful cleaning may be all that is required. If there appears to be no missing teeth or jammed parts carefully attempt to spin the hands of the clock by rotating the gears with light pressure from one of your fingers. If, like in my case, there appeared to be no problems with the mechanical aspects of the clock. I then proceeded to inspect the electrical components.

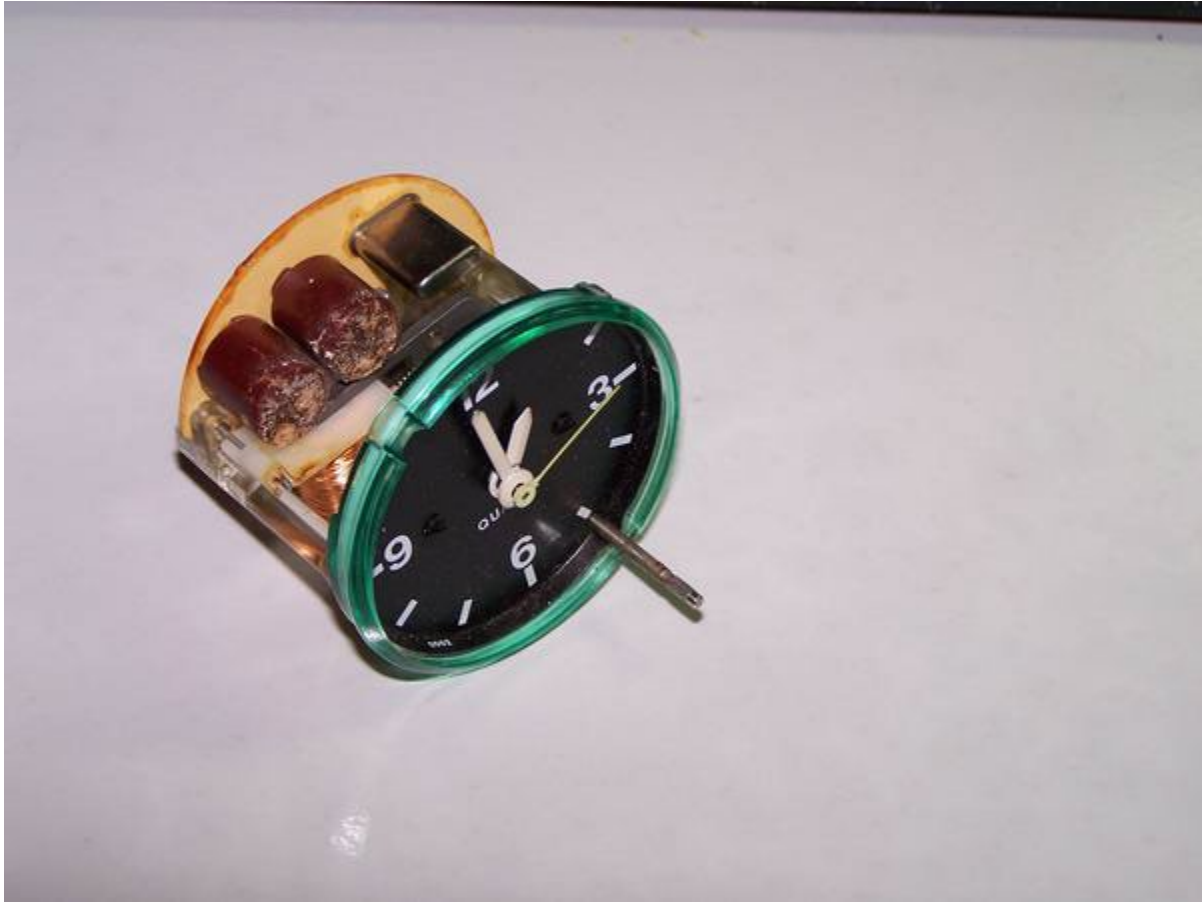
Since I had read that the **most common electrical failure was due to failed capacitors**, I visually inspected these two components very closely and found a crusty residue on them that seemed to indicate an overheating situation at some point in time.

I do not have at my disposal, any means to test a capacitor, so I concluded that since these were the only components that did not appear to be in near new appearance, that there was a good chance they had failed.

The markings on the top of my two capacitors were 100/16 meaning 100 microfarads and I believe 16 Volts.

A trip to the local Radio Shack electronics store produced two replacement capacitors. I had several choices based on differences in voltage ratings. I chose to go with a component with a 50 volt rating based on the assumption the higher voltage rating would allow the device to survive a higher temperature in the dash before failure.

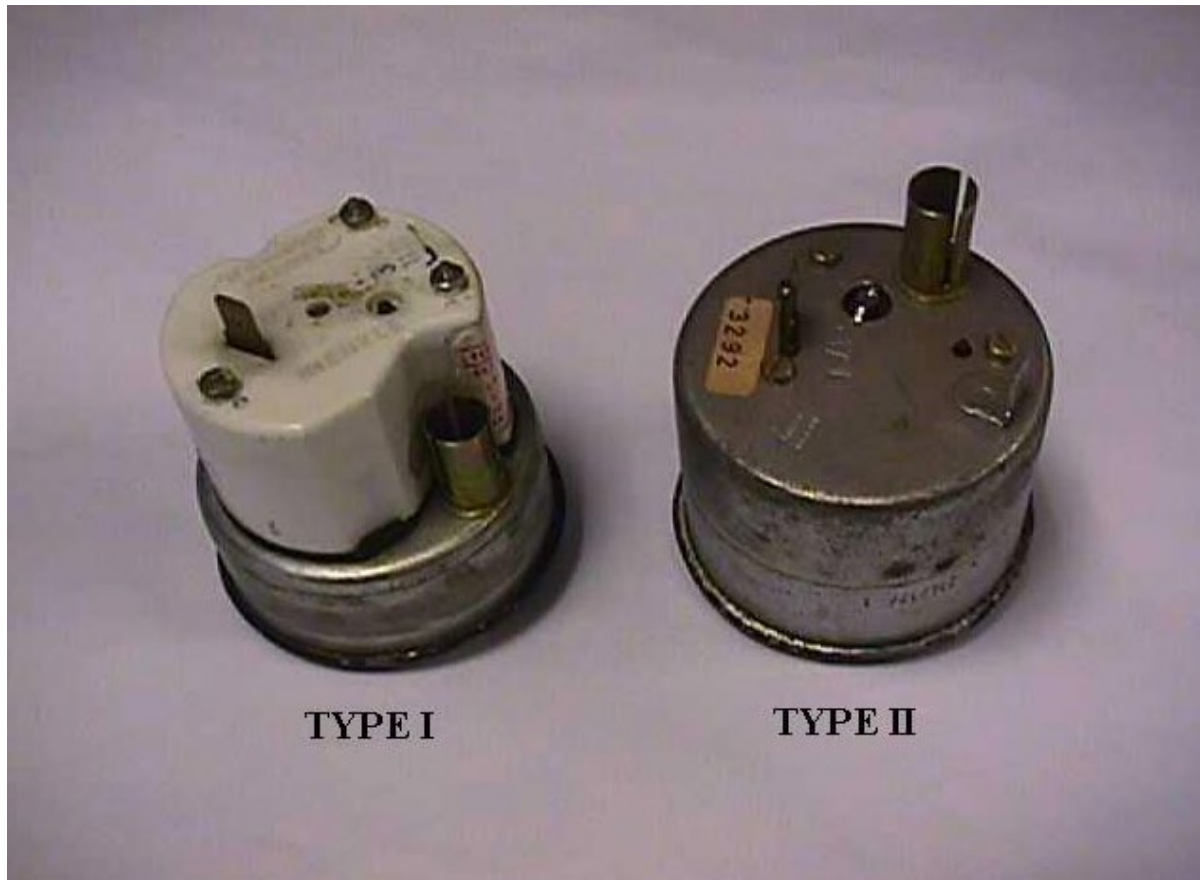
Figure 1 – Two different clock mechanisms

There are two types of clocks styles available in the 914 that I am aware of. Both look identical from the front, but are easily differentiated from the rear and have very different mechanisms inside. Both are shown in Figure 1. In the spirit of VW, I will refer to the clock on the left as Type I and the clock on the right as Type II. To the best of my knowledge, the Type I clock is the earlier model, and the Type II clock replaced it in 1973.

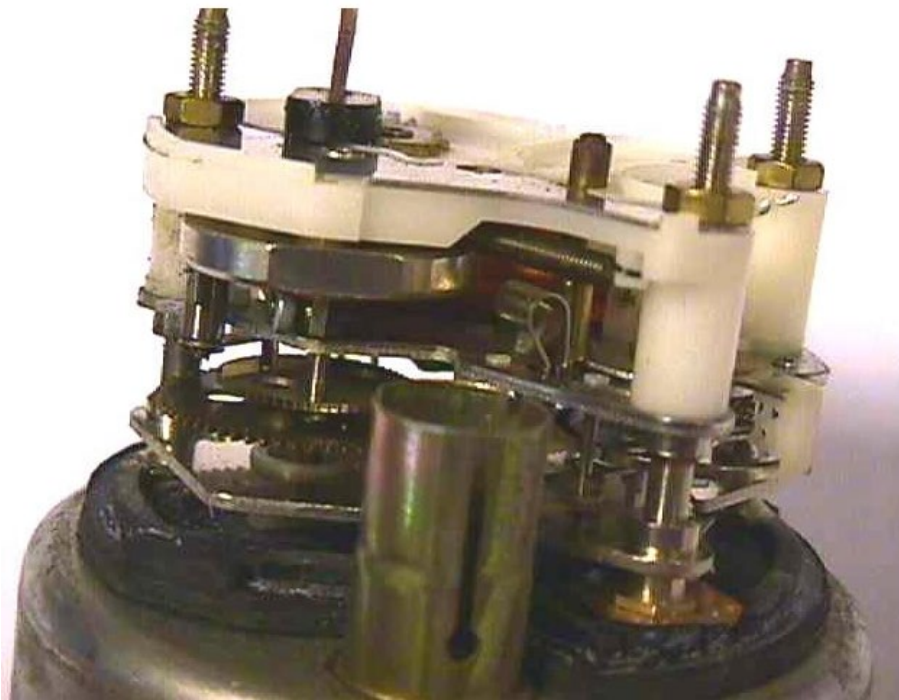
Figure 2

The Type I clock has an easily removable rear cover. Three small nuts are all it takes to remove the rear cover (you may need to break the small plastic that goes around these nuts if the clock has never been opened up before). Inside you will find a series of gears and a coil and a couple of springs (Figure 2). There is a steel disk about 3/4" in diameter near the rear end of the clock which has an electrical contact mounted under it. When this electrical contact is closed, current is sent to the coil which spins the steel disk around about 1/2 turn. This is how the clock is wound. The disk is spring loaded and will slowly over the course of about 3-4 minutes return to its original position - operating the clock as it goes around. When the contacts close again, the process starts all over again. For this reason, this clock only uses power for a fraction of a second every 3-4 minutes. You can turn the disk manually and see how this all works. The rest of clock works like a regular clock with all of the gears, etc.

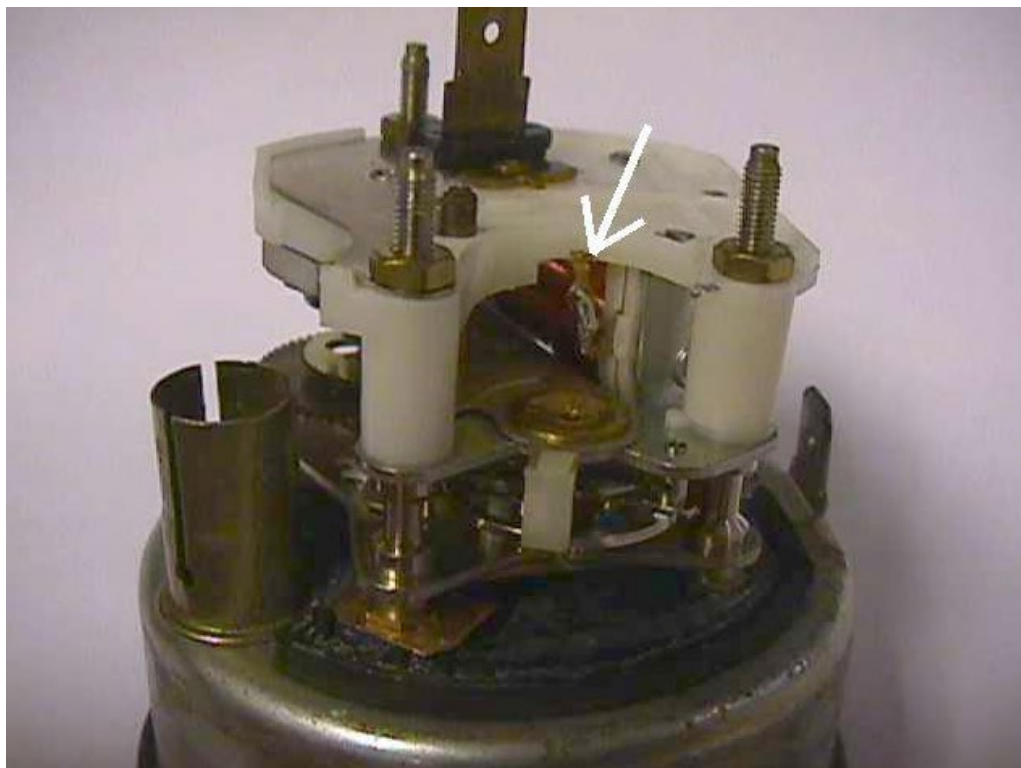
Figure 4

have to pry the formed flange up for at least 1/2 of the way around the clock, and then remove the clock ring and glass from the rest of the canister. Now it is time to remove the guts of the clock from the canister: remove the 3 screws from the rear surface of the clock and unsolder the ground connection (Figure 4). The guts of the clock should now slide out (Figure 5).

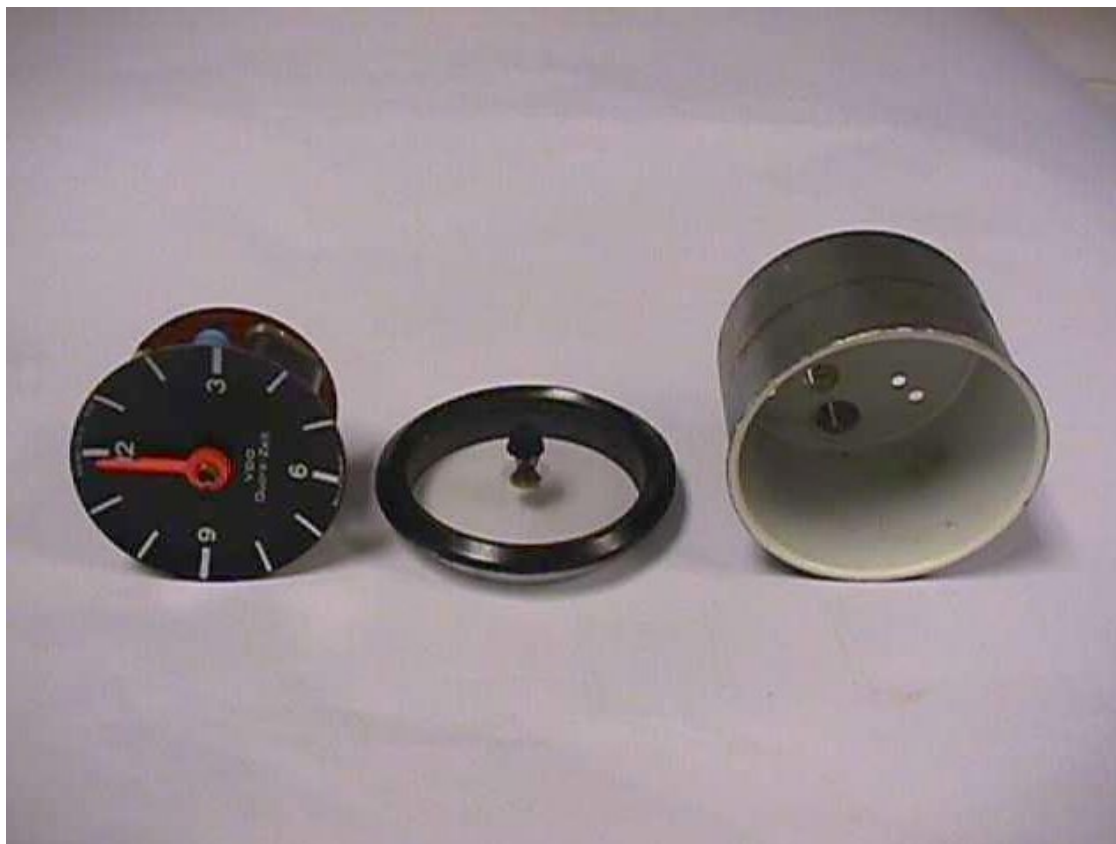
Figure 5

Once open, you will notice that the inside looks quite different from the Type I clock. This clock is run by an electric motor rather than a spring loaded disk wound by a coil. The most common failure with this type of clock is a damaged gear. In my case, it was a gear whose support shaft had broken. In order to fix this shaft, I wanted to separate the PCB portion of the clock from the gear portion (shown separated in Figure 6). This is possible to do given the following: Remove the obvious screw which holds the PCB on and unsolder the two posts which are arrowed in Figure 7. These two posts are how the electrical connection is made to the electric motor. If you do not unsolder these posts, the PCB is still very easy to remove, but your clock will never work again. The posts will come out with the PCB, but the very fine wires which go into the motor will break and there is no way to re-connect them (I know, I've tried - that's why the motor in Figure 7 is partially cut open). With the PCB removed, you can get access to do the gear repair. In my clock, I did the gear repair very carefully with epoxy, and then found out on re-assembly about the broken wires - but I am confident that the repairs would have worked had I not broken the wires.

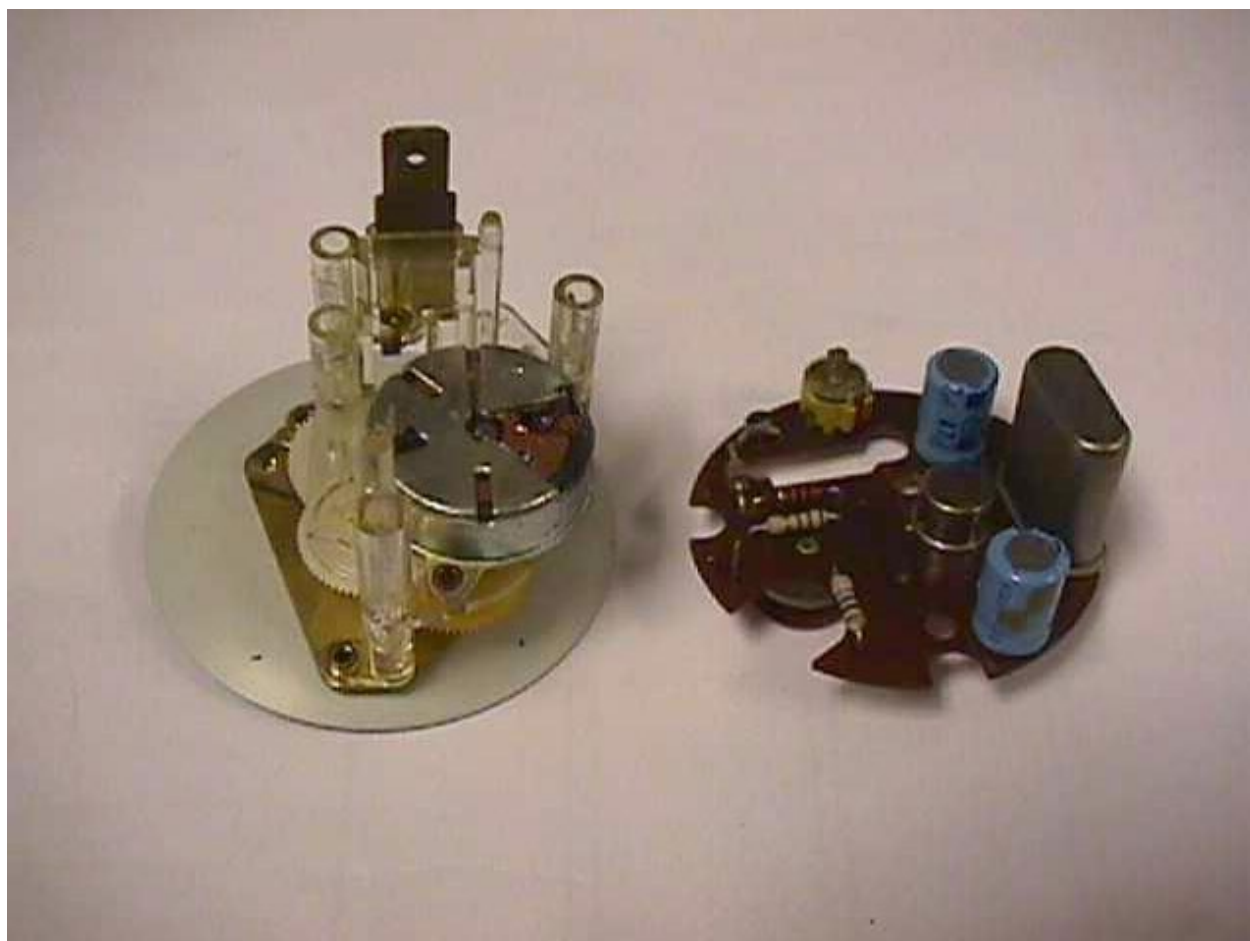
Re-assembly is just the reverse of this process. Test the clock before putting it completely back together (that face ring is really a pain - you don't want to do it twice). Also, note in Figure 6 that there is an adjustment pot mounted to the PCB. I believe that this pot is the clock speed adjustment and it is not accessible except by clock dis-assembly.
